Bolt Failure

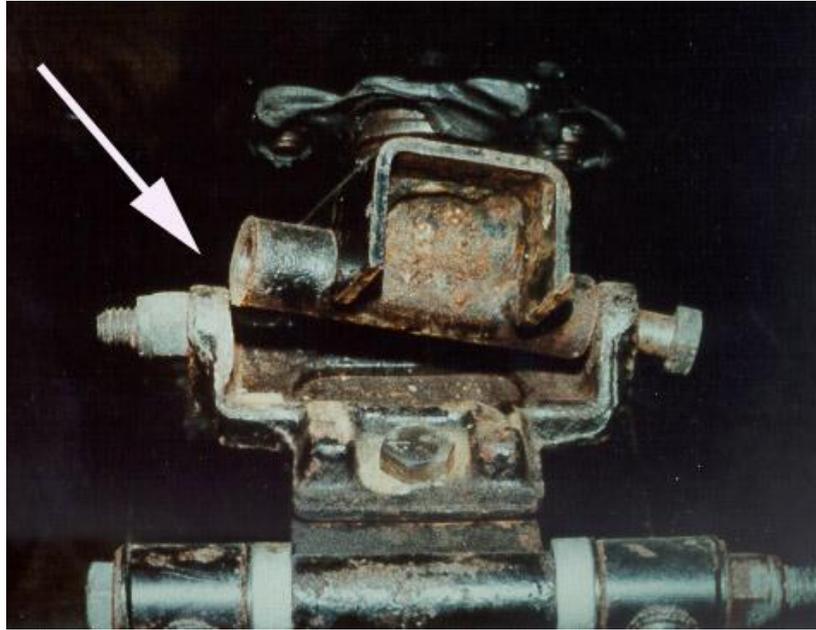
Snowmobile suspension bolt

The picture shows the front ski suspension system for a snowmobile. The operator of the snowmobile was badly injured when the sled suddenly veered to one side, throwing him into a tree. The bolt failed in the threaded section at a shear point in the bracket. It is generally considered poor design to allow significant alternating shear or bending forces in the vicinity of the threaded section of the bolt since the threads form a stress riser and tend to initiate fatigue cracks, as happened in this case. A better design would be to utilize a bolt with a shorter threaded section so that the unthreaded shank material is at the shear area of the bracket. This eliminates the stress riser from the threaded section and increases the effective bolt diameter.

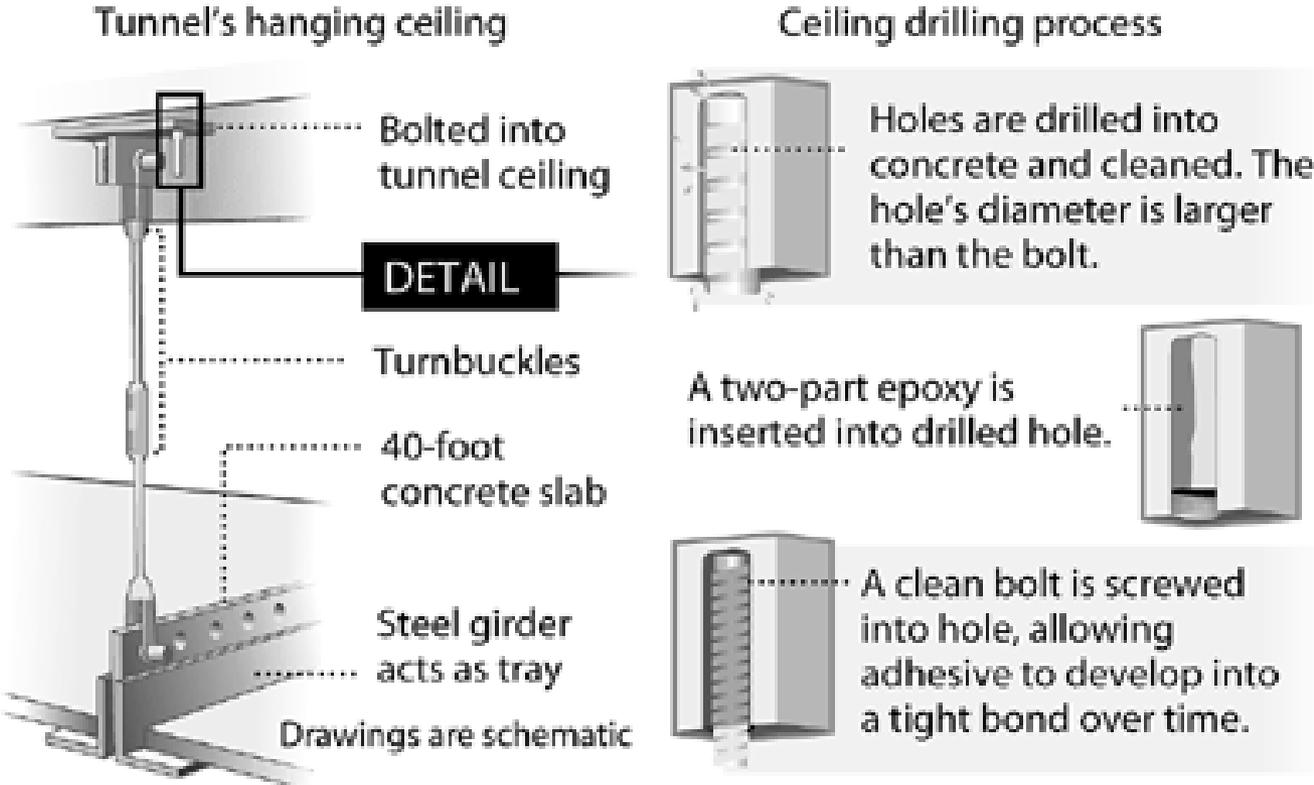
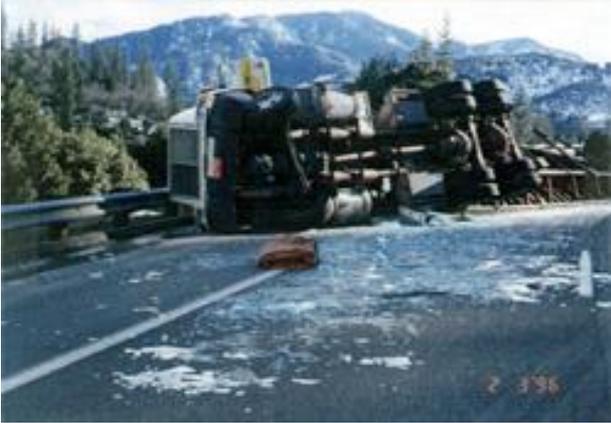
Loose bolts discovered at Big Dig

Boston's Big Dig tunnel, several tons of ceiling tiles fell and fatally crushed a motorist July 10, 2006

At least 237 suspect epoxy bolt hangers were found by inspectors where bolts were separating from tunnel ceilings at the Big Dig highway system in Boston.

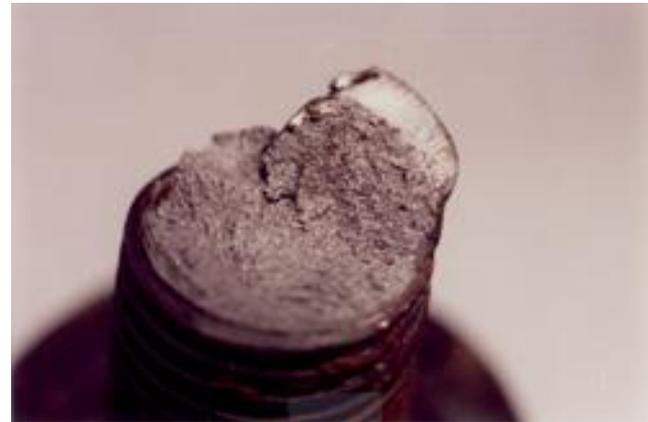
Heavy vehicle rollover collisions present special cases that often involve allegations of mechanical failure leading to rollover. In this specific case shown, the front axle u-bolt was alleged to have failed, causing the rollover.

But, photo shows the fractured u-bolt which indicates a single point overload failure with zero evidence of slow crack propagation or fatigue.

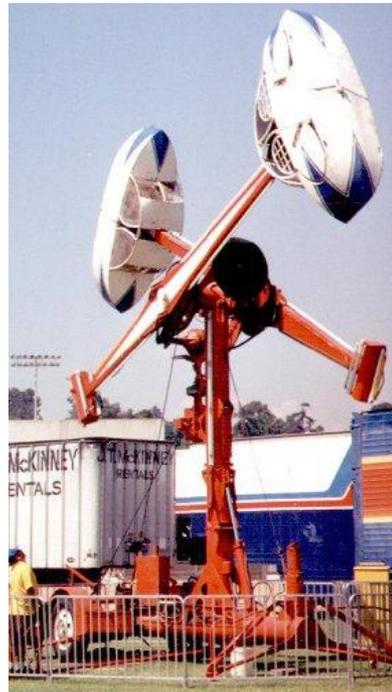
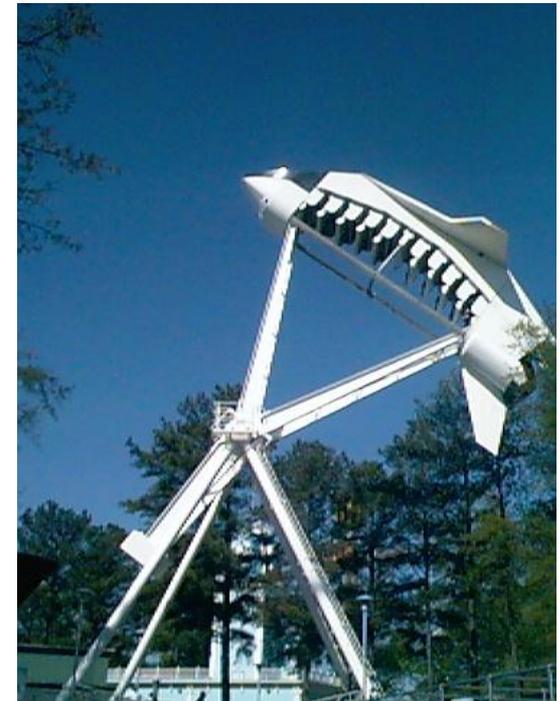
During the first two weeks of assembling a large new ride, large diameter bolts were breaking one to three days after they had been installed.

This ride is essentially a large boat with seating for forty people. It is connected via steel structural members to a central pivot point, much like a very large swing set. Directly opposite the "ship," above the pivot point, there is a connecting metal structure with a massive counterweight attached. When the ride starts, the ship is rocked back and forth in increasing amounts until the ship makes complete revolutions. The bolts that were failing held the counterweight to the structural frame. The bolts are 1 1/4" x 10", SAE Grade 5. The fracture surfaces had a craggy, rock candy appearance.

the most revealing test was core hardness. The readings were very low; in fact, when **Rockwell hardness readings were made directly in the center of the bolt, there were so soft it was as if the bolts were never heat treated at all.**

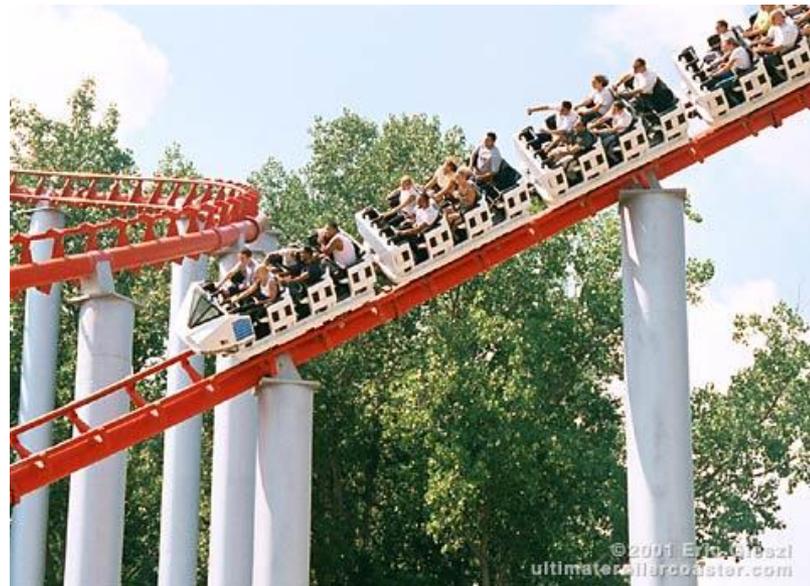
Hex socket shoulder screws, chosen as link pins between cars, were losing their heads. The remaining portions would then fall through the holes, causing the cars to separate.

Ultimately, some of the cars would jump the track and then crash while carrying occupants.

The machining process left small score lines in the area under the head. The score lines acted as stress risers that led to initiation of cracks under the violent forces of the ride. The cracks propagated until breakage, and the body of the screw dropped through.

Aided by a hand-held magnifier, the fracture surfaces of the failed products appeared to be clearly fatigue related.

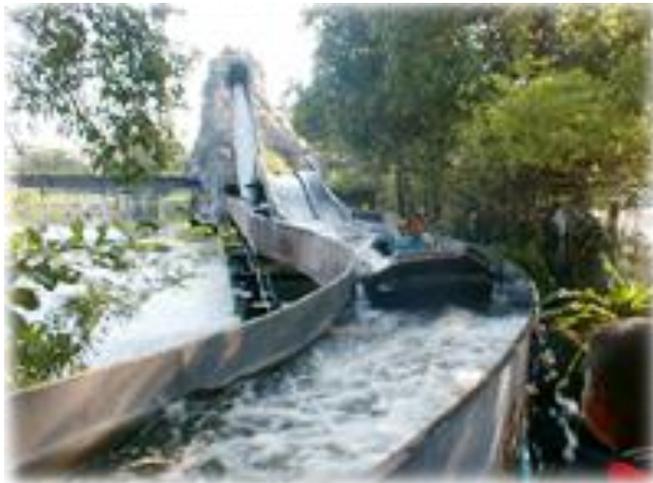
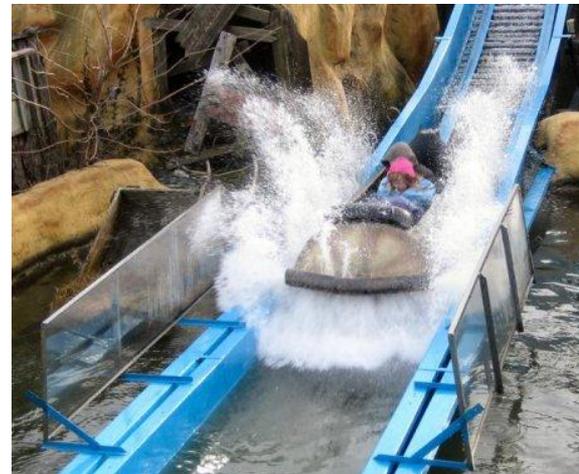
Bolts holding the wheels onto the axles were breaking at the head-to-shank juncture. The wheels would fall off, allowing the ride to float free. Some riders needed to be rescued by a boat and divers.

The forces acting on the head-to-shank juncture of the bolts were unreasonable and excessive, as the bolt heads had to absorb the force and shock of all movement cause by passengers entering and exiting the ride.

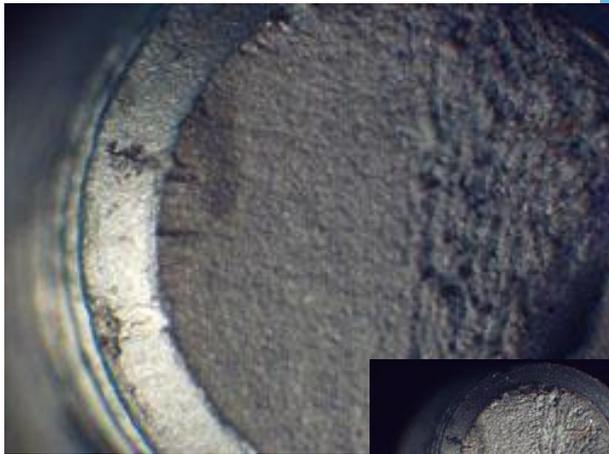
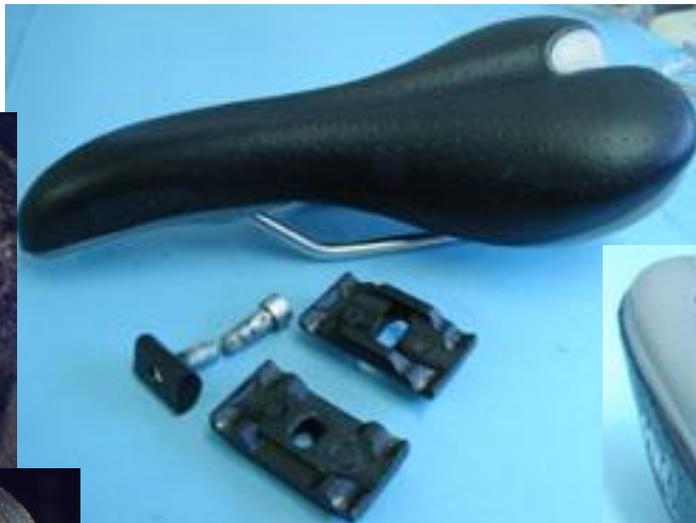
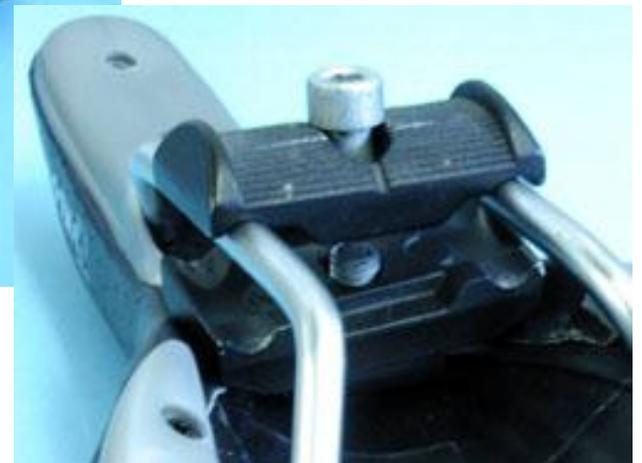
The bolt securing this saddle to the seat post broke while the rider was cycling. The bolt may have been loose causing an increased bending load on the screw thread. This failure occurred only three months after purchase. The bolt's function is to fasten a clamp onto the saddle rails, this transmits the seat loads to the seat post (not represented on the picture).

Because the lower part of the clamping system is serrated, it is not free to move if the bolt is only slightly loose. A bending moment is applied to the screw if the cyclist transfers their weight forward or backwards in the saddle. The geometry of the component loading therefore suggests that the failure might be caused by bending fatigue.

These magnified views of the fracture surface show two zones that confirm the hypothesis of bending fatigue. The fatigued zone (left half of the image) seems to have several initiation points.

The fatigue strength of this bolt is severely compromised by its threads. One possible improvement to its design would be to ensure that the part of the bolt that was likely to be exposed to bending stresses was not threaded.

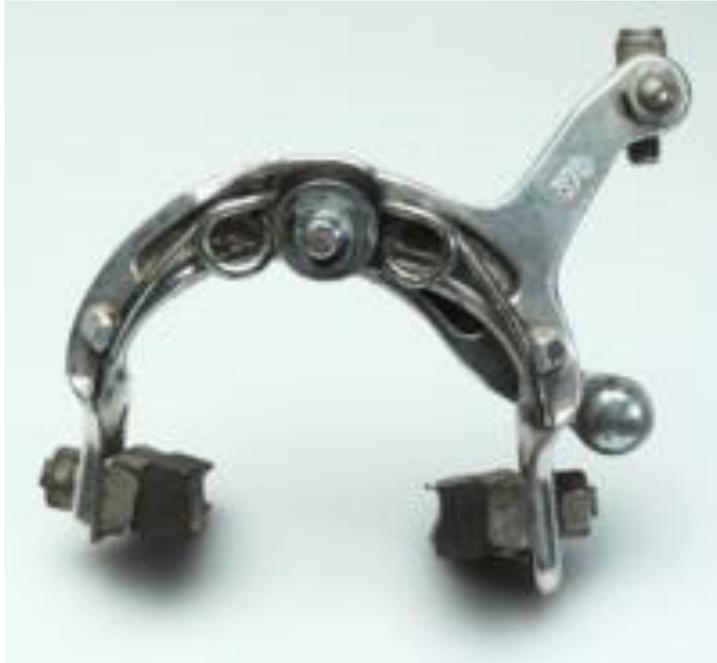
This front brake assembly broke off under braking and severely injured the cyclist. Poor maintenance had allowed the brake bolt to loosen and allow the assembly to "chatter" when braking imposing cyclic loads instead of steady stress on the fastening bolt.

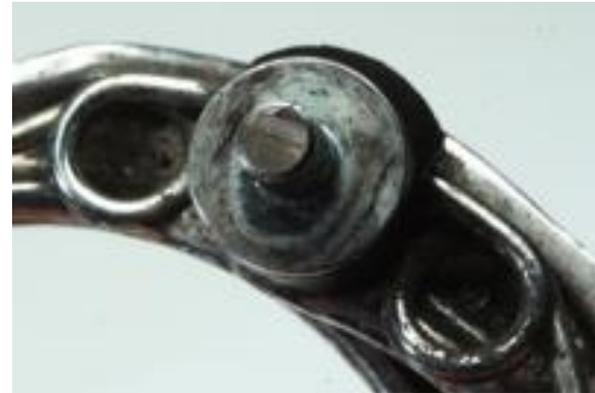
As can be seen at higher magnification the failure was caused by bending fatigue in the steel brake mounting bolt which should be firmly secured through the cycle fork.

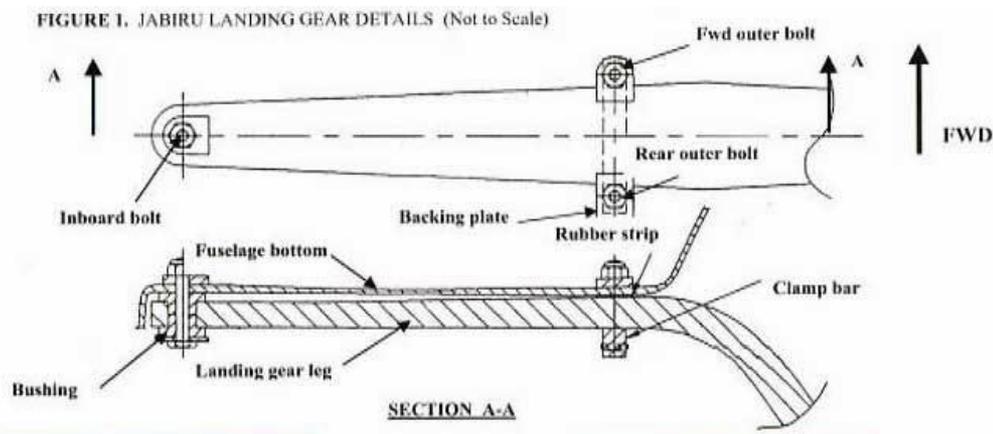
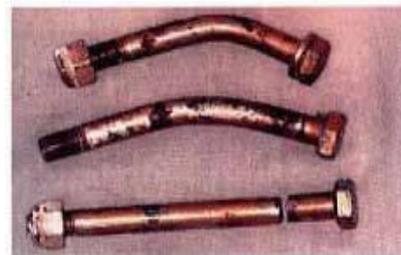
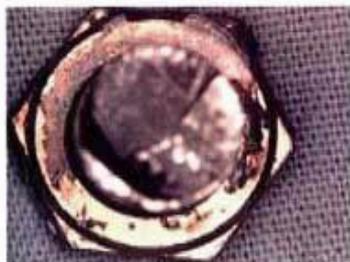
Of the three bolts, one had failed approximately 20 mm from the underside of the head and the remaining two were intact but bent. The geometry of the landing gear is such that the landing shock loads tend to deflect the legs forwards; this imparts the greatest stress on the rearmost of the outboard bolts and it was this one that failed.

(Photo: H F Consultants)
FIGURE 1b. Underside of fractured bolt head showing lack of damage to plating. Thrust face of associated nut showed similar lack of damage

The examination revealed that the bolt failure had occurred as a result of a simple bending fatigue mechanism, with multiple initiation sites. There was evidence, in the form of a relative lack of smearing of the cadmium plating on the thrust face of the nut and the underside of the bolt head, which suggested that the assembly had not been fully tightened. This would have reduced the bolt's fatigue resistance. The condition of the forward outer bolt was the same, although the inboard bolt appeared to have been adequately tightened. It was noted that the threaded end of the inboard bolt contained at least three fatigue cracks in the thread roots. The result of investigation suggested that that one or more of the bolts may have been insufficiently tight, allowing movement of the gear leg within the clamp.
